**Draft Report
Halibut PEI Phase 1**

May 1, 2009

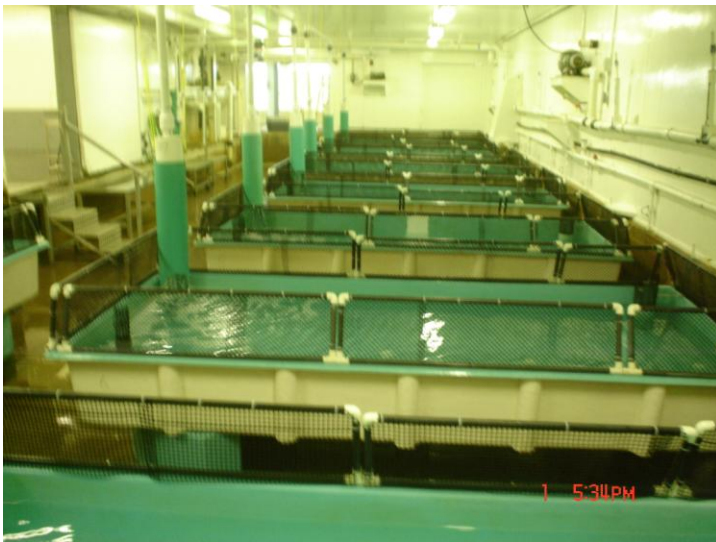
Figure 2: Fiberglass tank set up

Three sizes of tanks were used, because of their availability: 3.65m X 1.83m (2.34m³), 3.65m X 1.52m (1.94m³), and 3.65m X 1.22m (1.56m³). These tanks were equipped with 20 cm diameter, 56 cm long gas scrubbers previously used for lobster holding. These were modified with the addition of two water distribution plates supporting 2.5cm Bio Barrels (Aquatic Eco-Systems, Inc., FL) to optimize gas exchange. A line from a regenerative blower was connected to each scrubber to increase the air flow through the incoming water. In case of water flow shut down, oxygen was available at each tank delivered via fine pore diffusers for oxygen (Aquatic Eco-Systems, Inc., FL). The tanks all had rigid hardware cloth ("Vexar") wall extensions to allow for 40 cm of extra height

to prevent jumping (Figure 2). Eventually it became necessary to completely close in the top of the tanks with similar mesh to prevent jumping over the top of the walls.

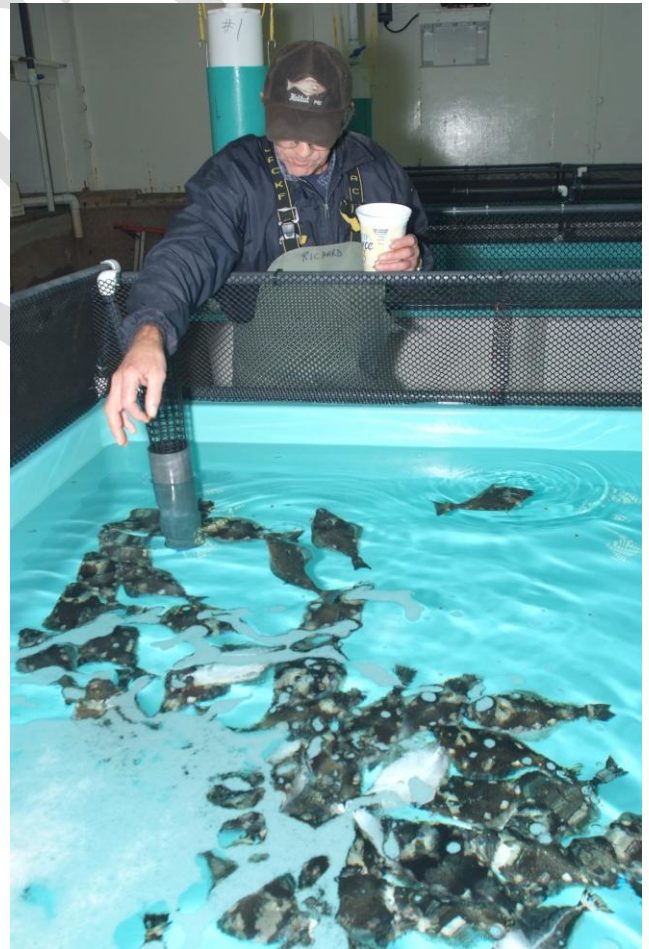
Figure 3: Release of Group 1 fish into fiberglass tank

On October 2, 2008, 743 fish, at approximately 150g mean weight, were transferred from Scotian Halibut Limited to Halibut PEI's facility (MorningStar lobster plant) in Victoria, PEI. The fish were trucked to the facility by Scotian Halibut Limited in oxygenated sea water held in modified 1 m³ plastic fish tote boxes. Upon receipt, the fish were netted out of the tanks into self draining tubs which were carried to and emptied into eight fiberglass holding tanks (Figure 3).

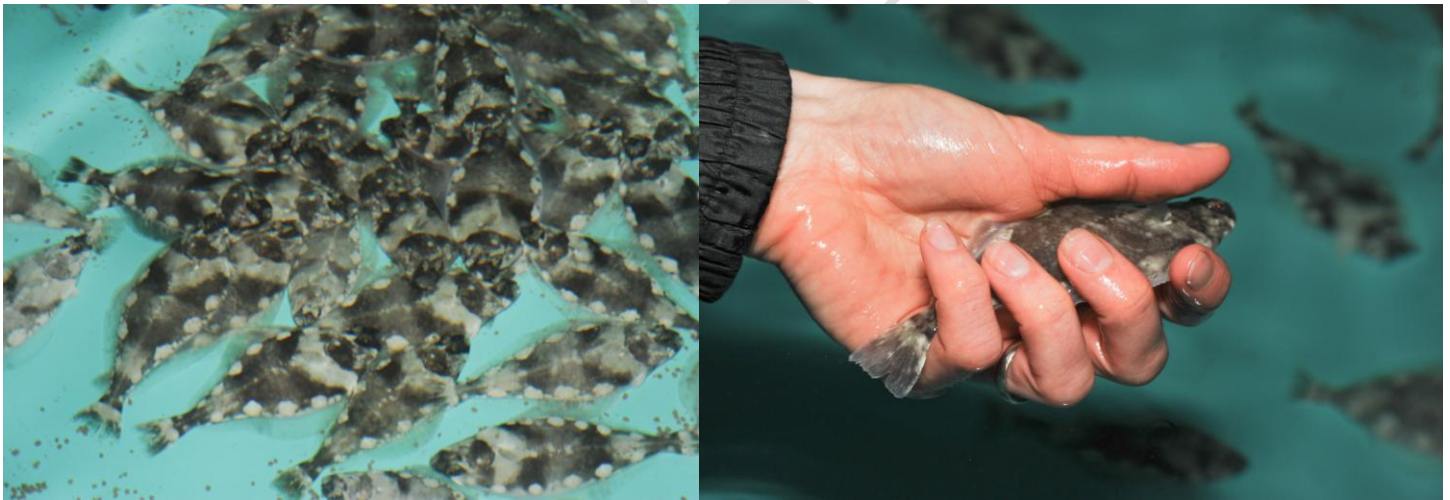
Figure 5 A, B: Group 3 fish

On February 12, 2009, 178 juvenile halibut with a mean weight of approximately 13.5g were transferred in buffered, oxygenated water in sealed plastic bags in styrofoam coolers from Scotian Halibut Limited to Halibut PEI's facility in Victoria, PE. They were all released into one fiberglass tank (1.56m³) after a one hour temperature acclimation was performed by floating the sealed bags in the recipient tank.

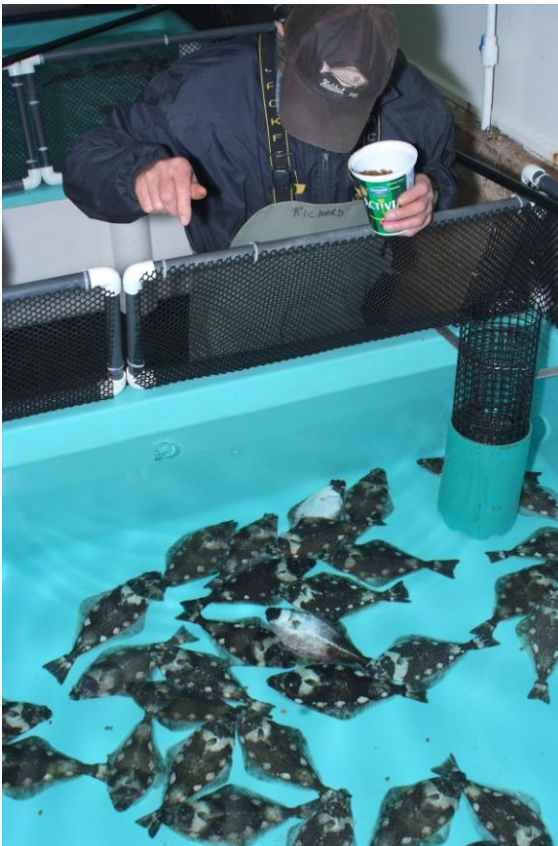
Figure 6: Feeding Group 1 fish

Water quality was checked and fish were fed to satiation a minimum of twice daily. Fish were offered Corey AquaSea diet for marine fish in a 5mm pellet: 50% protein, 14% fat, 18.9MJ/kg digestible energy (Figure 6). Feed offered each day was recorded along with oxygen, temperature, salinity and differential gas pressure. Oxygen levels were maintained at optimum (greater than 8.5mg/L or 88% saturation) to enhance appetite and reduce any stress on the fish.

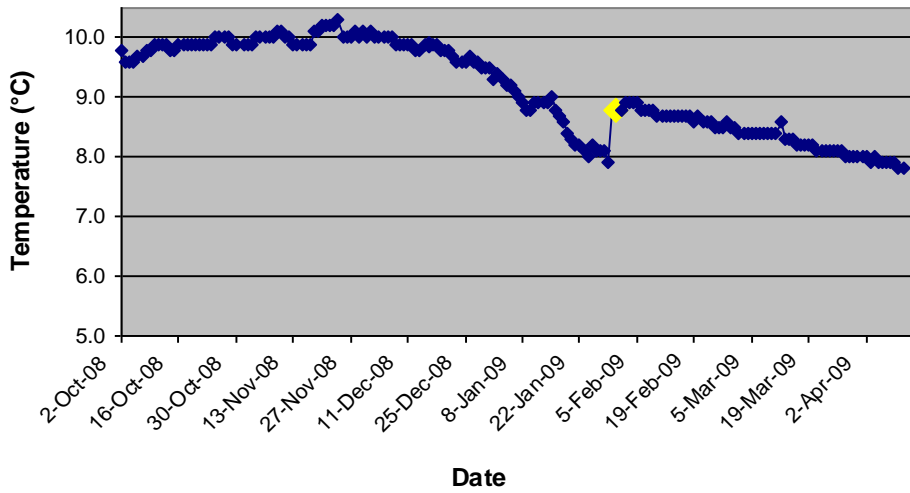
Figure 7: Temperature profile of water in fiberglass tanks. The yellow point represents the day after the well water source was switched.

All tanks were subjected to the same water quality conditions since they were supplied with the same water. Initially, the water was derived from Well #1. The temperature in the fiberglass tanks remained close to 10°C until mid December when it began to drop appreciably (Figure 7). Soon after reaching 8°C, the tank water supply was switched to Well #3 – temperature 8.8°C. The salinity of the tanks changed gradually but with regular fluctuations when on Well #1, eventually peaking between 26 ppt and 27 ppt. Regular fluctuations were still apparent after switching to Well #3 but were less marked (Figure 8). Oxygen levels were maintained above 85% saturation by adjusting water flow. Total gas pressure hovered around 100% (Figure 9). pH was not a concern in the tanks because of the high turnover and low stocking densities. It was measured on one occasion and all tanks were within the range of 7.70 to 7.71. Water clarity remained excellent. Some tanks were noted to have low spots where some debris settled but nothing of significance.

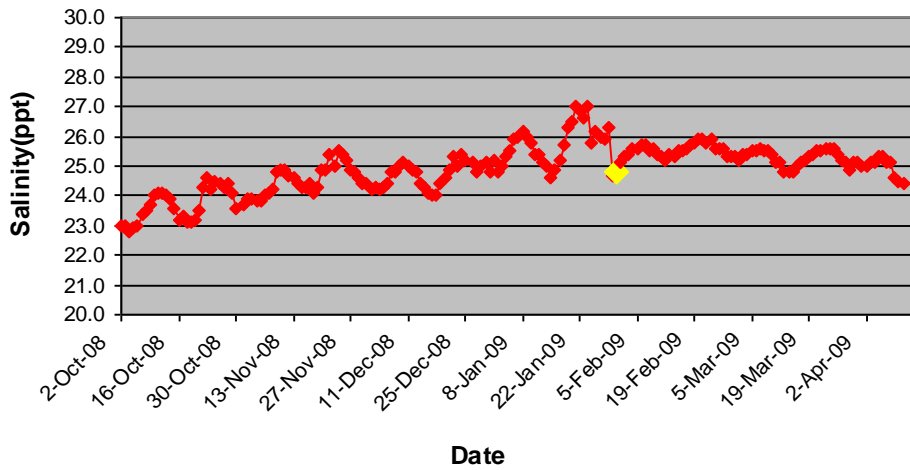
Figure 8: Salinity profile of water in fiberglass tanks. The yellow point represents the day after the well water source was switched.

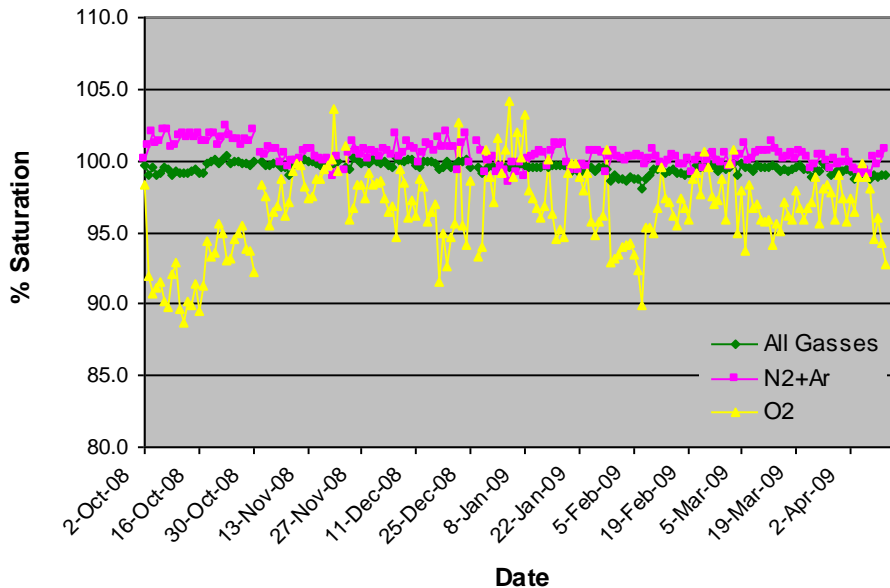
Figure 9: Gas profiles of water in fiberglass tanks

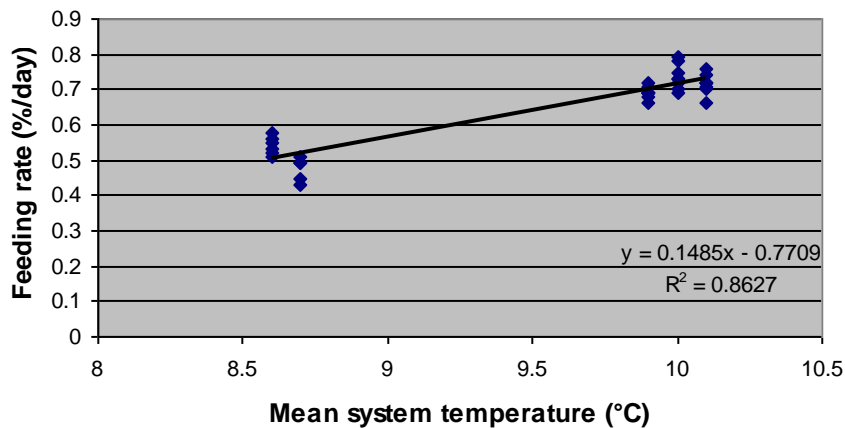
Figure 11: Effect of temperature on feed consumption

Feeding began within a day of transport and remained strong throughout, though the decrease in water temperature later on did inhibit feed consumption. (Figure 11). Handling for biomass determination also inhibited feed consumption the following day. Feeding rates ranged from 0.43% to 0.79% body weight per day. Feed conversion ratios averaged 1.2 over the sampling period. Specific growth rates ranged from 0.31% to 0.86% and were also affected by temperature (Figure 12). There was no significant tank effect on fish performance (growth and food conversion).

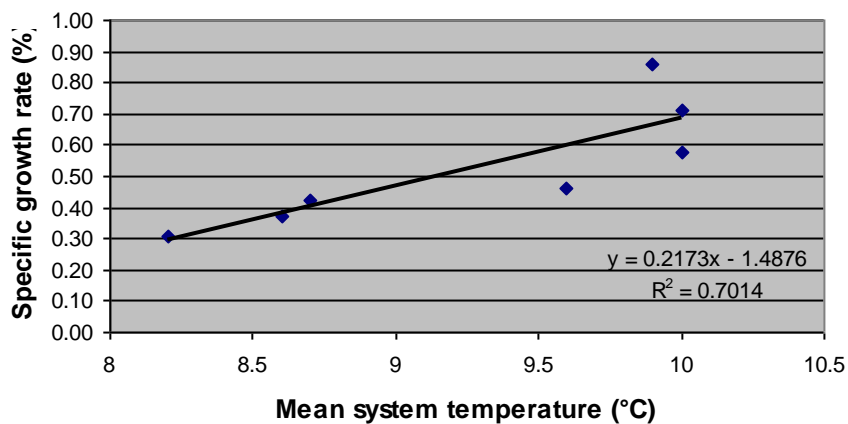
Figure 12: Effect of temperature on growth

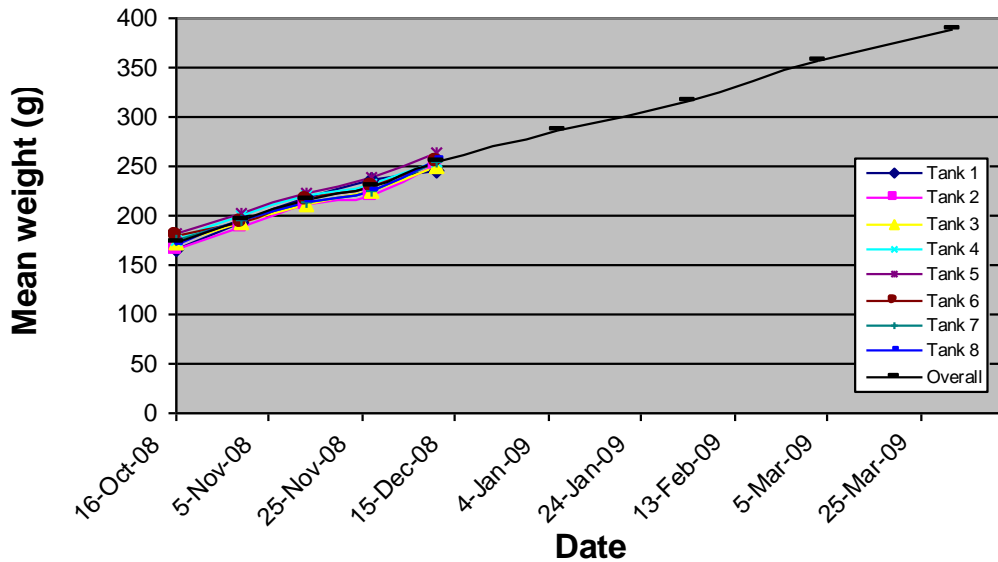
Figure 13: Growth of Group 1 halibut. (Groups are combined after the first grade)

The Group 1 fish achieved a mean weight of 389g by the end of the study (Figure 13). A broad size distribution was noted in the fish with the smallest fish estimated at being less than 100g and the largest fish greater than 500g.

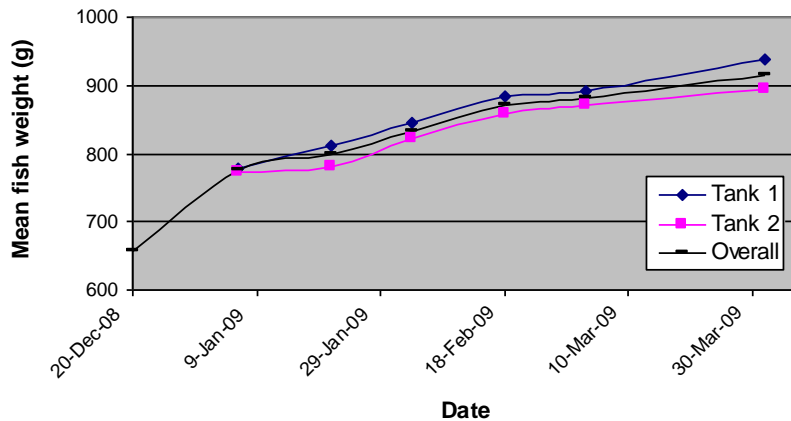
Figure 14: Growth of Group 2 halibut. (Initial weight sample did not designate

tank.)

In the fiberglass tanks, the Group 2 fish achieved a mean weight of 914g by the end of the study (Figure 14). Initial growth was excellent. It tailored off in the latter part of the study (post mid February). A broad size distribution was noted in the fish at the end (Figure 15). We quantified this by weighing individuals on April 9, 2009. At this time size ranged from 523g to 1584g. One of the smallest fish (543g) was found to be a precocious male with running milt.

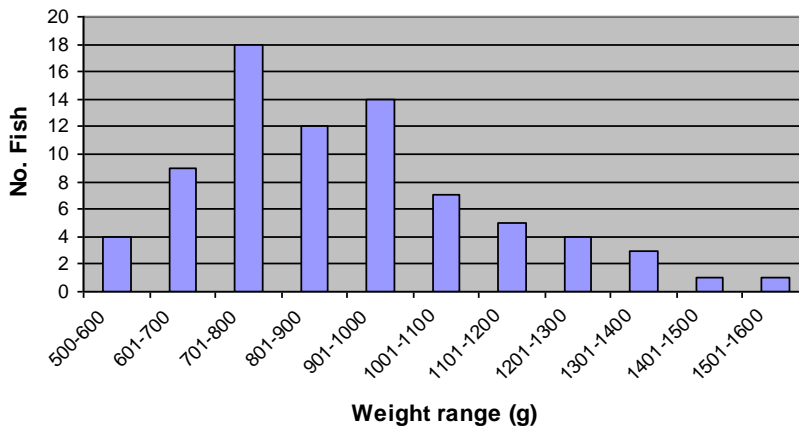
Figure 15: Size distribution of Group 2 fish in fiberglass tanks at the end of the study (N=78)

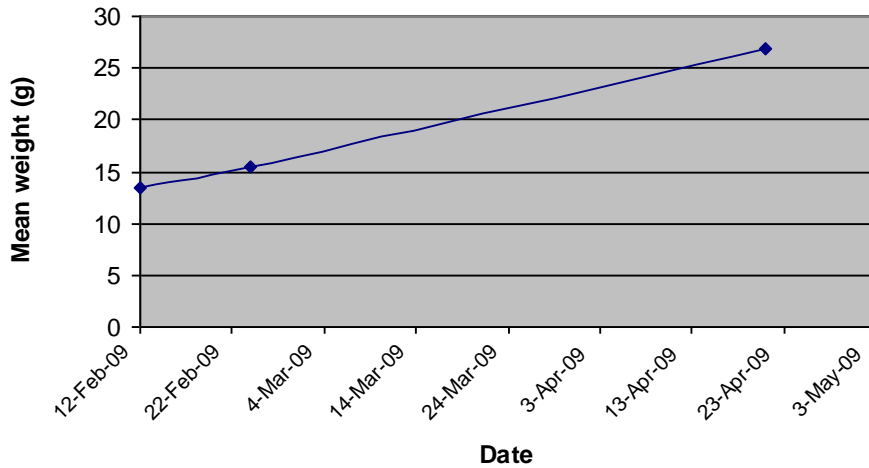
Figure 16: Growth of Group 3 halibut

Feed was constantly left on the tank bottom to reduce competition. Little feeding response was noted in these fish. Pellets were eaten off the tank bottom with no feeding in the water column observed. Feed was offered at 3-5% body weight per day. Specific growth rate averaged 1.0% over the sampling period. The Group 3 fish achieved a mean weight of 24.9g by the end of the study (Figure 16).

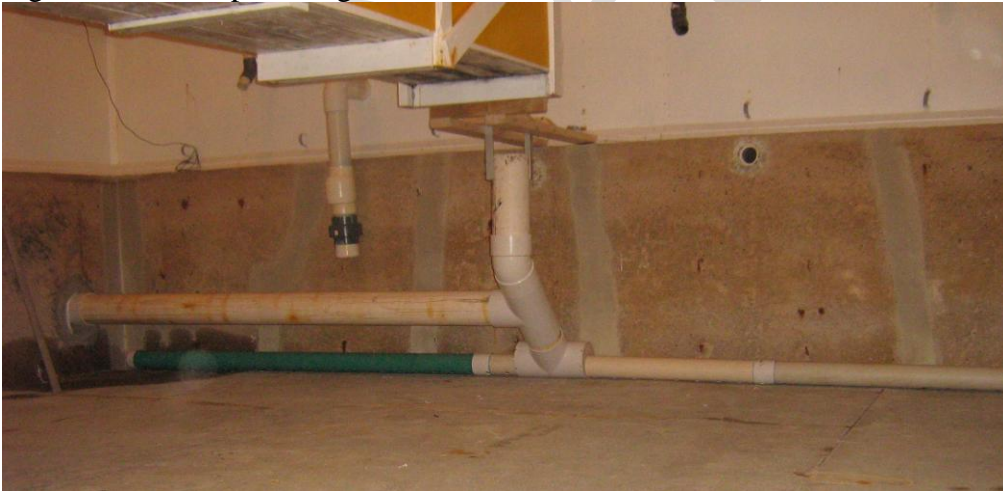
Figure 18: Drain plumbing for Tank 1B

To allow drainage, a 25cm diameter hole was cut into the 25cm thick concrete wall of the tank to accommodate 2 of 15.2cm (6") female threaded bushings. These bushings would allow easy dismantling of the tank when return to lobster holding was required. The location of the hole was determined by the plumbing design of the tank drain. All discharge plumbing was sized for 600 lpm flow. Void areas of the wall around the plumbing were patched with hydraulic cement which was then sealed with PQ 4020 (Edco Technologies Inc., Permaquick), a two part (A + B) cement sealing compound). A 10cm diameter (4") pipe on the floor of the tank along the back wall (Figure 18) was drilled to form the drain with hole number and size allowing maximum suction pull from each hole. The first 0.9m outer ends of pipe had 2.5cm diameter holes at 10 cm centers while the central 1.8m sections of pipe had 2.0cm holes at 10 cm centers. This would allow an effective surface area of 96cm² on each side, ample for the expected 300 lpm flow per half of the drain pipe, while still causing good suction and promoting self cleaning of the pipe and tank. When the drain pipe was removed from the tank in mid April there was absolutely no fouling evident on the holes or the pipe itself indicating a self cleaning flow of water. A surface drain consisting of an open ended 15cm (6") pipe with Vexar mesh to prevent fish escape was also incorporated into this pipe to accommodate overflow and prevent airlocks. The surface drain did not always skim the surface properly and an ability to adjust its height would have improved surface cleaning action. The floor drain and surface drain were connected to an external standpipe that could be pulled for tank flushing. All effluent water drained into a drum filter.

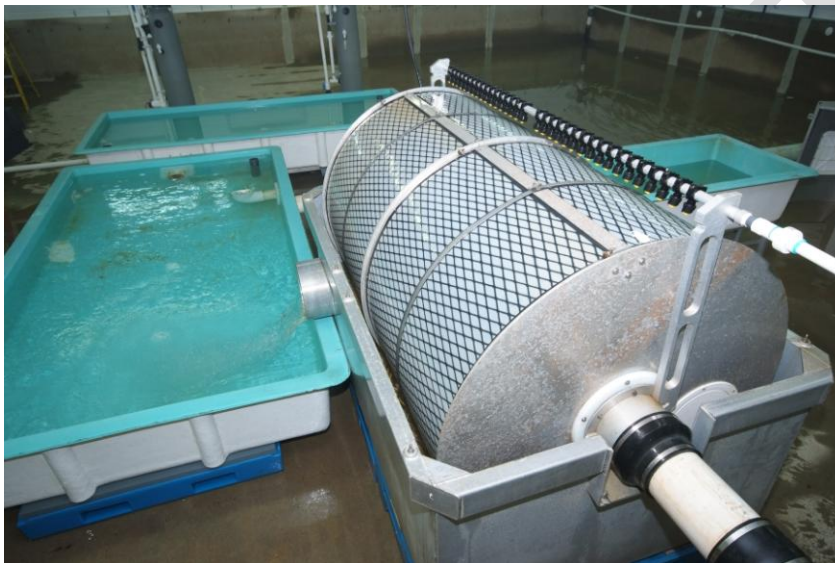
Figure 19: Drum filter for effluent water

The drum filter used was a Model 4672 from Aquacare Environment, rated at 5000lpm for a 40µm screen (Figure 19). 50µm screens were installed for this study. Discussions with the manufacturer revealed that more realistic expectations for this unit would be 3000-4000 lpm because of the design of the water inlet. This was still much greater than anticipated flows for this demonstration tank system.

A jet pump receiving water from the salt water well was hooked up to the spray bar unit to provide water to rinse down the screens. The jet pump operation was controlled with a pressure switch. This set up was very effective when on constantly. We experienced problems (drum motor burn out) when we attempted to operate the unit on a timer linked in conjunction with a solenoid valve. Having the solenoid valve operate under control of a float switch located within the drum would likely improve the efficiency of the design. This was not accomplished within this study because the design of the drum filter was not conducive to this set up and major alterations would have been necessary. Several maintenance experts and an engineer were consulted on how to do this. Plans were made to do so and will be implemented before the drum filter is put into operation again.

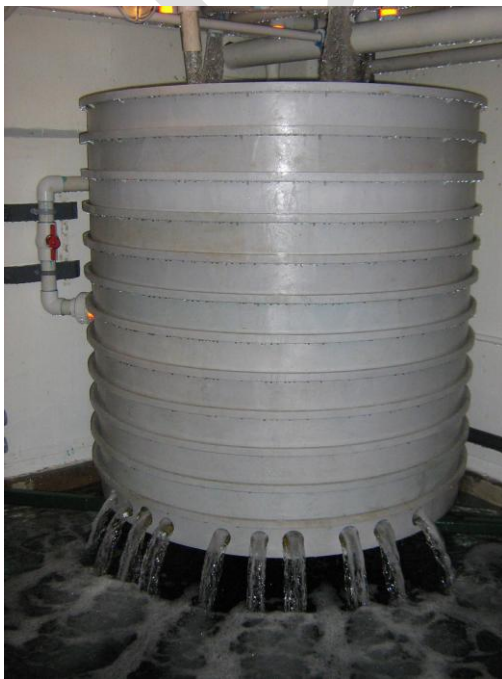
The inflow was designed to allow gas passage into and out of the water via an improvise scrubber. The scrubber was composed of stacked lobster holding trays with holes drilled in each tray to allow free air passage throughout (Figure 20).

Figure 20: Lobster tray modification
Figure 21: Scrubber in use in Tank 1B

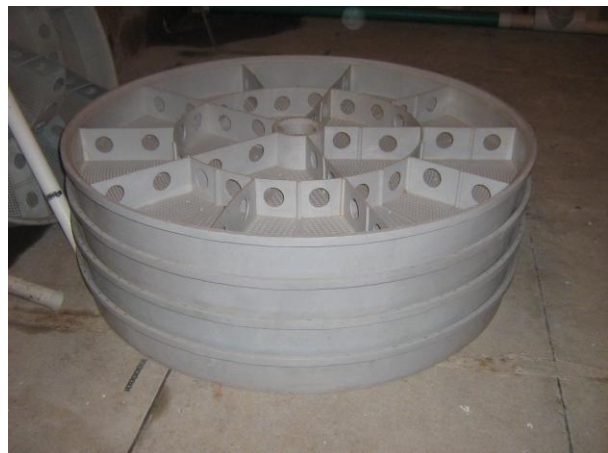
The stack height was 1.4 m (12 trays, Figure 21) as determined by the clearance required to make adjustments to the inflows, if necessary. Inflow arrangement was critical for this design due to the large surface area available for the water to pass through. Water was well distributed in the scrubber via a four outlet water distributor, taking advantage of the full surface area available (Figure 22).

A line from the air blower was also hooked into the scrubber to allow air to be blown through its center trays to increase the G/L (gas/liquid) ratio and maximize its degassing ability. This could be particularly important for its putative future use to remove CO₂. In particular, the air to be blown through the scrubber would be from an external source and not contain an increased CO₂ component as air from the tank environment could. No bio-barrel addition was required since the lobster trays were successful at balancing the nitrogen and oxygen saturation levels of the water (Table 2).

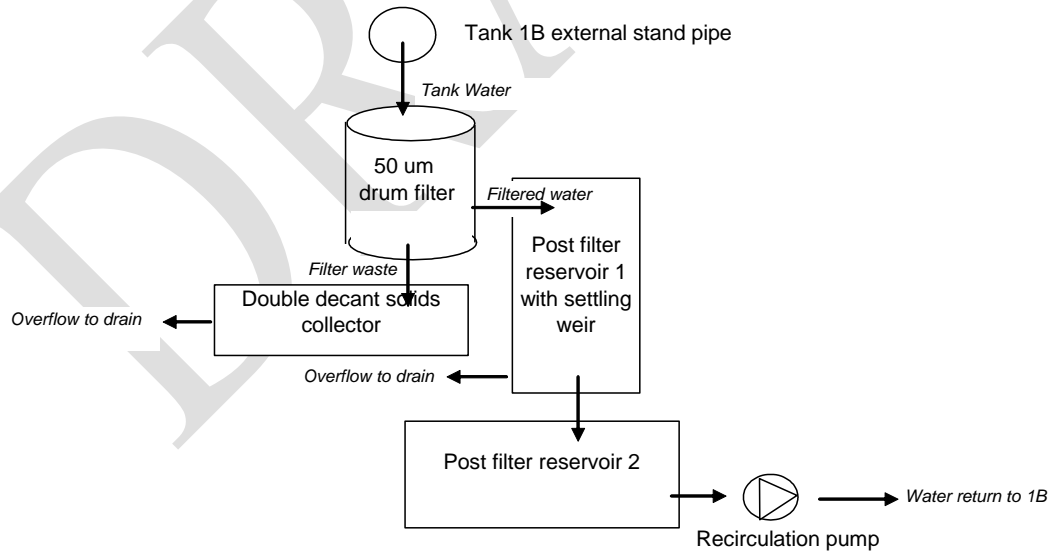
Figure 23: Schematic representation of Tank 1B effluent and recirculating water flow

Water flow was turned on in Tank 1B December 15, 2008, several days before fish arrival. The flow was originally set by measuring the time taken to increase the tank water level 5 cm. Initial attempts to measure flow were confounded by leakage from the stand pipe so a dedicated solid stand pipe was made for the purpose of measuring tank flows. Flow was controlled with valves discharging water into Tank 4B, another lobster holding tank on the same water line. There was no valve in line to Tank 1B to allow direct water flow control. After the fish addition make up water flow was decreased until excessive debris was noted in the water of the tank. This occurred at a flow rate of 500 lpm. This represents a tank turnover every 88 minutes.

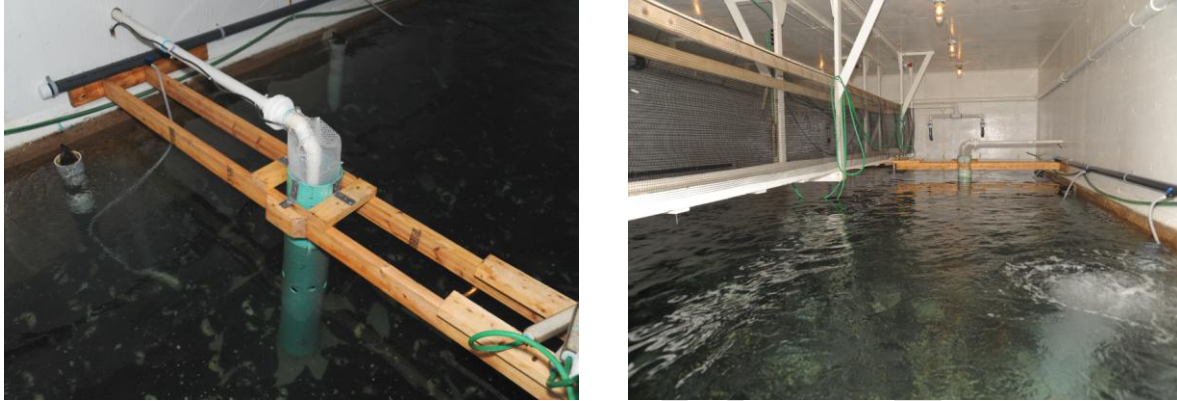
Figure 24 a, b: Pump sleeve piping and placement for foam fractionator feed

A foam fractionator (RK25-PE Model from RK2 Systems), rated for 100-150 lpm water flow, was installed in early February and turned on February 10, 2009 to extract mid stream water from the tank for clarification of the fine suspended solids. A water fall pump was inserted in the base of a 20cm diameter pipe sleeve with holes drilled midway.

This pump provided the foam fractionator with 115 lpm of water. Many people were consulted on how to run the foam fractionator. Opinions varied greatly and all differed from the unit's instructions. We decided to try it at many different settings and discovered that balancing air flow and internal water flow gave the best results. This balance often had to be reset after re-starts. It was suggested that the tank water was not dirty enough for optimal foam fractionator performance. The suspended solids with halibut feces were evident only with diffracted light illumination. The water always appeared clear when viewed from the walkway except at the morning feeding. More evaluation will be required to demonstrate the advantage of maintaining foam fractionation for fish at this density.

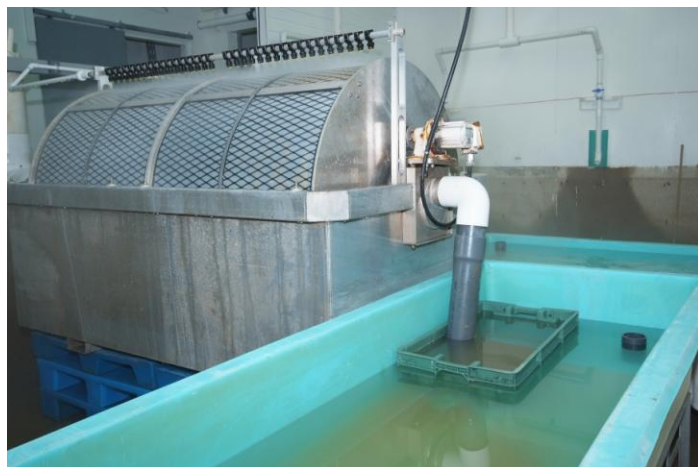
Water which passed through the drum filter had very little suspended solids. Watching the effluent with an offset light source only a few small bits of mucus could be seen leaving the collecting tank. Water that was reused was taken from a connected tank and some superficial oil scum occurred over a week long period and only small bits of debris accumulated in the tank. Because the post filter water was very clear with minimal fines present and it took so long to collect sufficient material to look at, our effluent study concentrated on the material that was filtered by the drum filter and sent to a separate collection tank. Solids from the drum filter effluent separated quickly into two parts- heavy material that settled quickly into a tote box and light material which decanted off the tote box then out of the tank. This material was white to brownish and stayed suspended in the water for a long time.

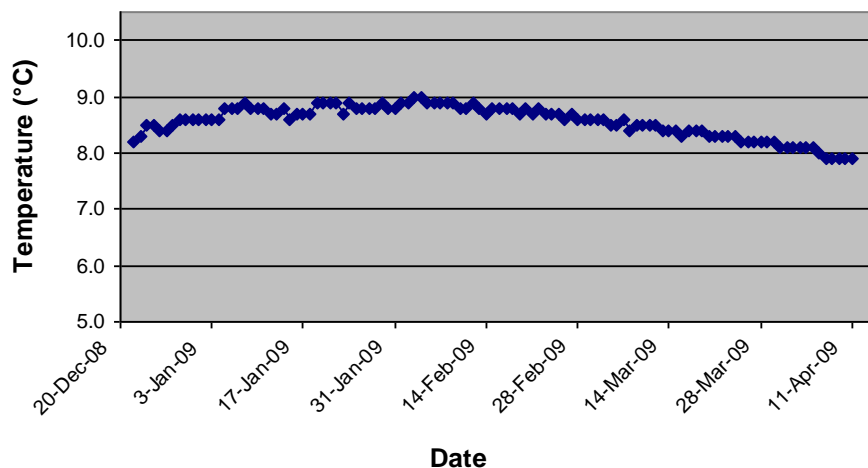
Figure 26: Temperature profile for Tank 1B (Well #3)

Tank 1B was supplied with water from the highest producing well on the premises - Well #3. A detailed water quality analysis was performed on this water and has been appended. The make-up of this water was very similar to that of the other well tested - Well #1, suggesting a similar source from two different aquifers.

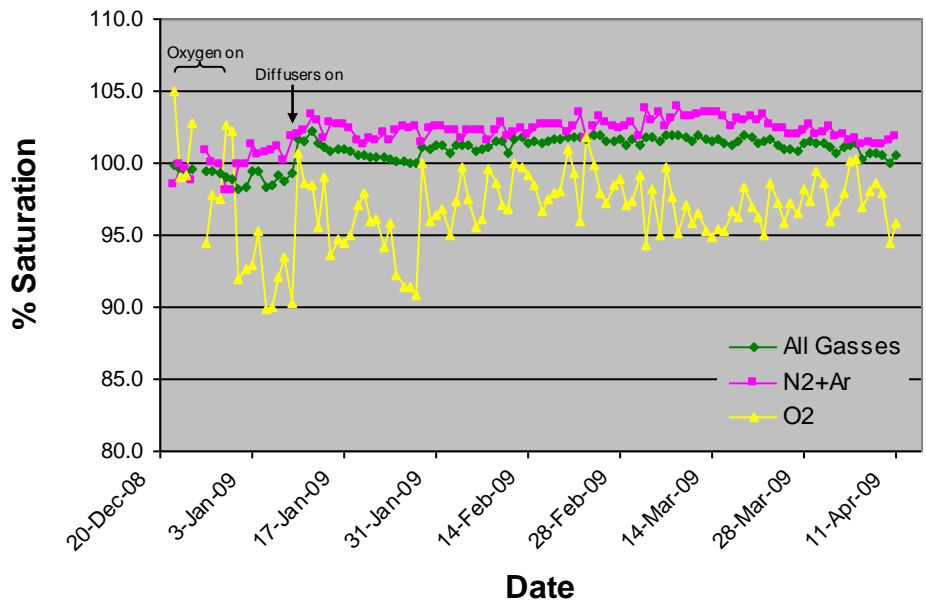
As mentioned previously, the scrubber was successful at balancing the oxygen and nitrogen components of the incoming water. However, it was necessary to turn on air diffusers in the tank to increase oxygen levels. This effectively increased oxygen levels but also caused a slight increase in total gas saturation and saturation levels of nitrogen (Figure 28).

Figure 28: Water gas saturation levels for Tank 1B. (Measurements taken in tank beside scrubber.)

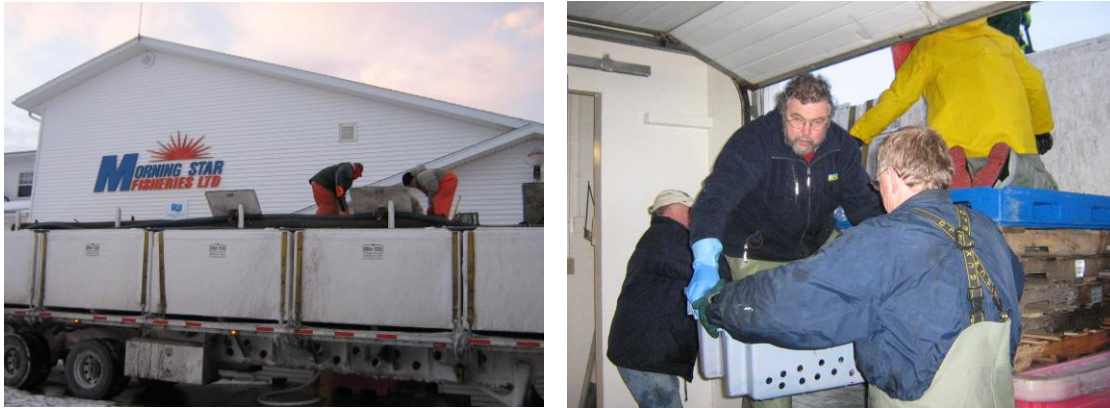
Figure 29 a, b: Unloading of 650 g fish.

On December 20, 2008, the fish arrived at approximately 6 am. They were delivered by C. MacIntosh Trucking in square smolt delivery tanks. The fish were unloaded by dip netting out of the transfer tanks into porous totes and carried by hand (Figure 29).

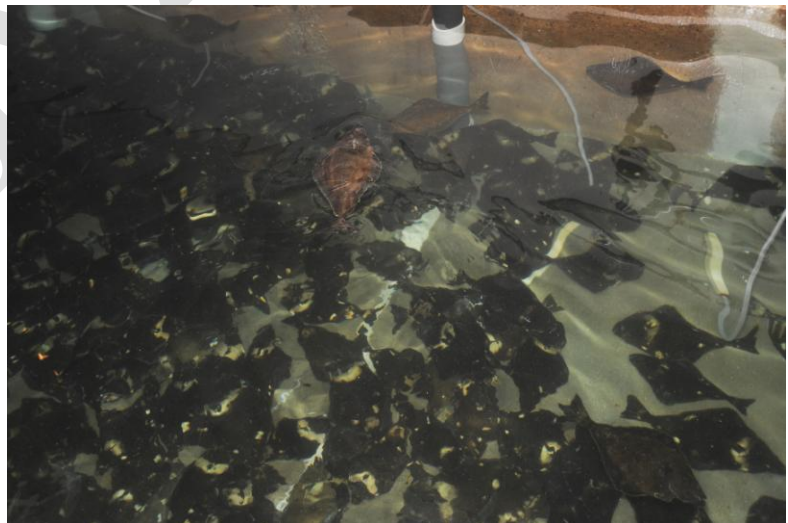
Figure 30: Fish in Tank 1B

Initial attempts were made to weigh and count fish prior to entry to tank but the time taken was excessive so that finally only weighing was done. The fish count done by Scotian Halibut Limited would be used. The biomass determined by Halibut PEI was 937 kg. This is very close to the biomass of 948 kg reported by Scotian Halibut Limited. At the time of unloading, 82 fish were put into 2 of the fiberglass (1A and 2A) tanks as mentioned above. More fish arrived than anticipated. Initial stocking density was estimated at 113% coverage or 18 kg/m².

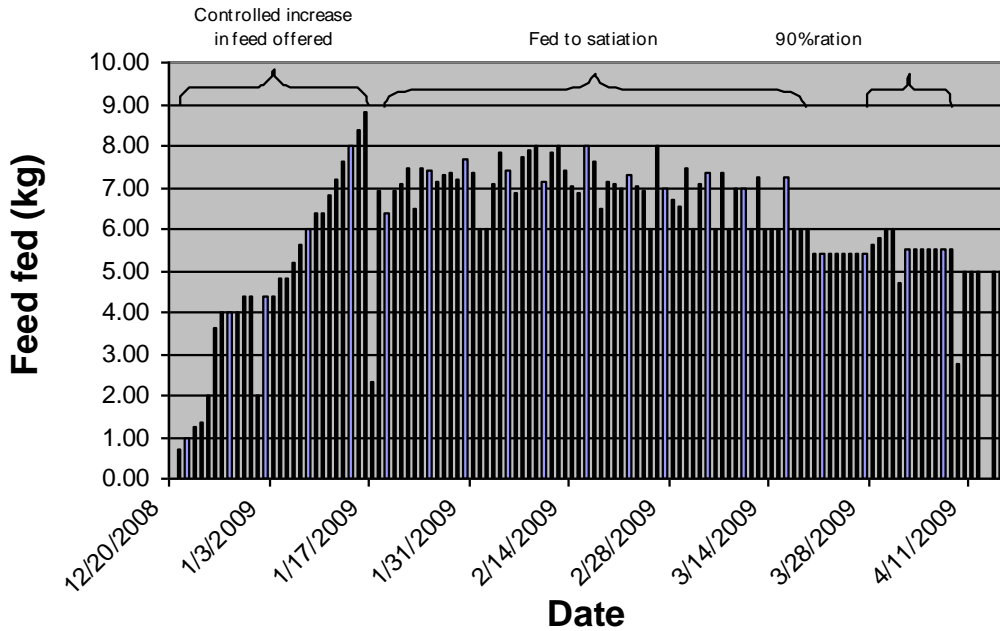
Figure 31: Amount of feed offered to Tank 1B daily.

Fish were initially on reduced rations and feeding was increased slowly over the next few weeks (Figure 31) to assess system performance. Fish fed ravenously within days. They were generally fed twice daily; an occasional third feeding was attempted if feeding was slower than normal or if activity around the tank disrupted a feeding. In late January, a red light was used as operative conditioning to cue the fish that the feeding session would begin. This allowed them to differentiate from the many visitors using the overhead walkway.

Feeding was slightly reduced for a week in March in order to collect feces. For this period, a 90% ration was offered in an attempt to ensure that all feed was eaten so that collected matter would only be feces and no uneaten feed.

When we returned to feeding to satiation again in April, feed offerings were lower than other months, despite an expected increased biomass due to growth. This was likely the result of staff being better trained to assess the end point of feeding and reduced appetite of fish due to a decrease in temperature.

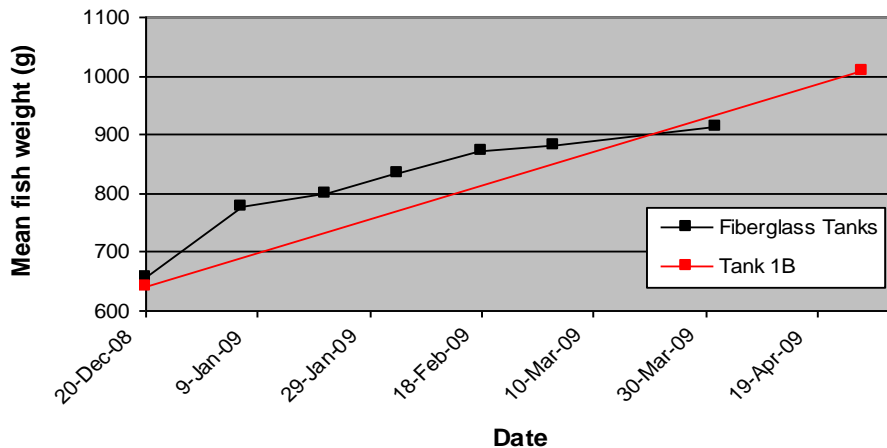
Fish grew very well in the concrete tank (Figure 32). A preliminary size assessment suggested a mean weight of 1007g by the end of the study. This represents better growth than the fish in the fiberglass tanks when temperature is considered. An overall FCR of 1.5 was estimated.

Figure 32: Growth of Group 2 fish in fiberglass tanks and the concrete 1B Tank.
